NATIONAL DAM INSPECTION PROGRAM UPPER BRIDGEPORT DAM NDI I.D. N--ETC(U)

PHASE I REPORT
NATIONAL DAM INSPECTION PROGRAM

Upper Bridgeport Dam: NDI I.D. No. PA-00465

Owner: Municipal Authority of Westmoreland
County

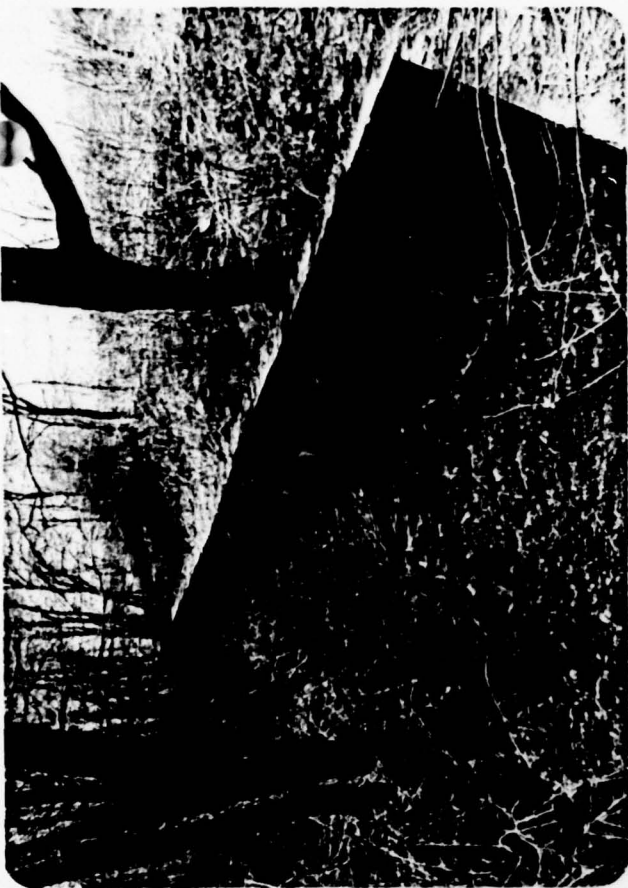
PHOTOGRAPH 6 View of the concrete retaining wall along the downstream slope of the embankment section between the two spillways. The wall extends to the right abutment but is interrupted by the emergency spillway.

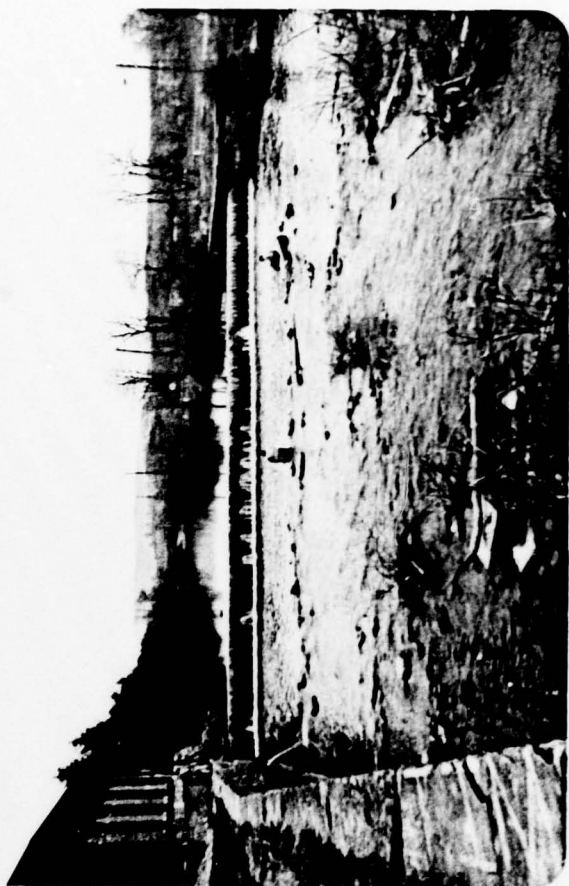
PHOTOGRAPH 12 View of Lower Bridgeport Dam situated approximately 2,400 feet downstream from Upper Bridgeport Dam.

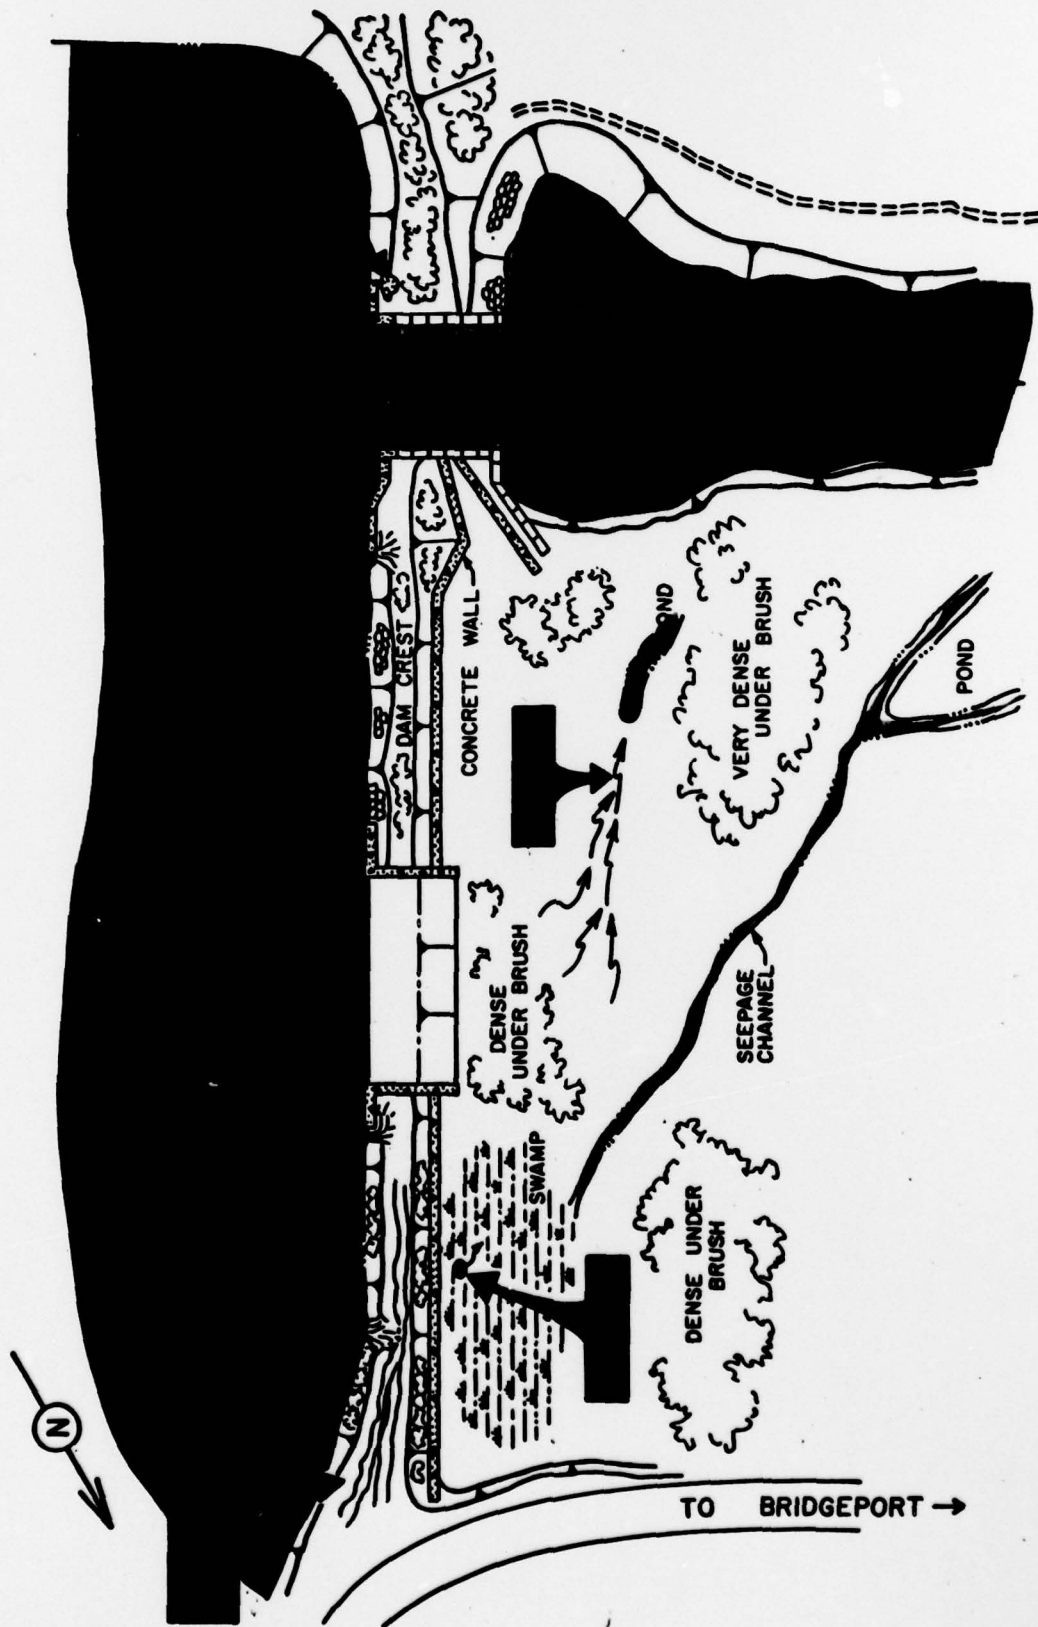
FIGURE 1 - UPPER BRIDGEPORT DAM

1. Embankment. The embankment, as shown on Figure 1, was constructed of earth atop a clay foundation. No records of compaction procedures or construction techniques are available. A concrete corewall was installed in 1894 which reportedly extends from the right abutment to the left wingwall of the service spillway, a length of about 800 feet. No outer corewall details are available. Cross-sectional dimensions, specifically, heights, crest widths, and slope angles vary significantly along the embankment.
